TECHNICAL REPORT NO. LWL-CR-06C66A

AIRCRAFT MOUNTED PERSONNEL DETECTOR CHEMICAL

Final Phase IV Report
Contract No. DA-18-001-AMC-983(X)

By
Ordnance Systems
General Electric Company
Pittsfield, Massachusetts 01201

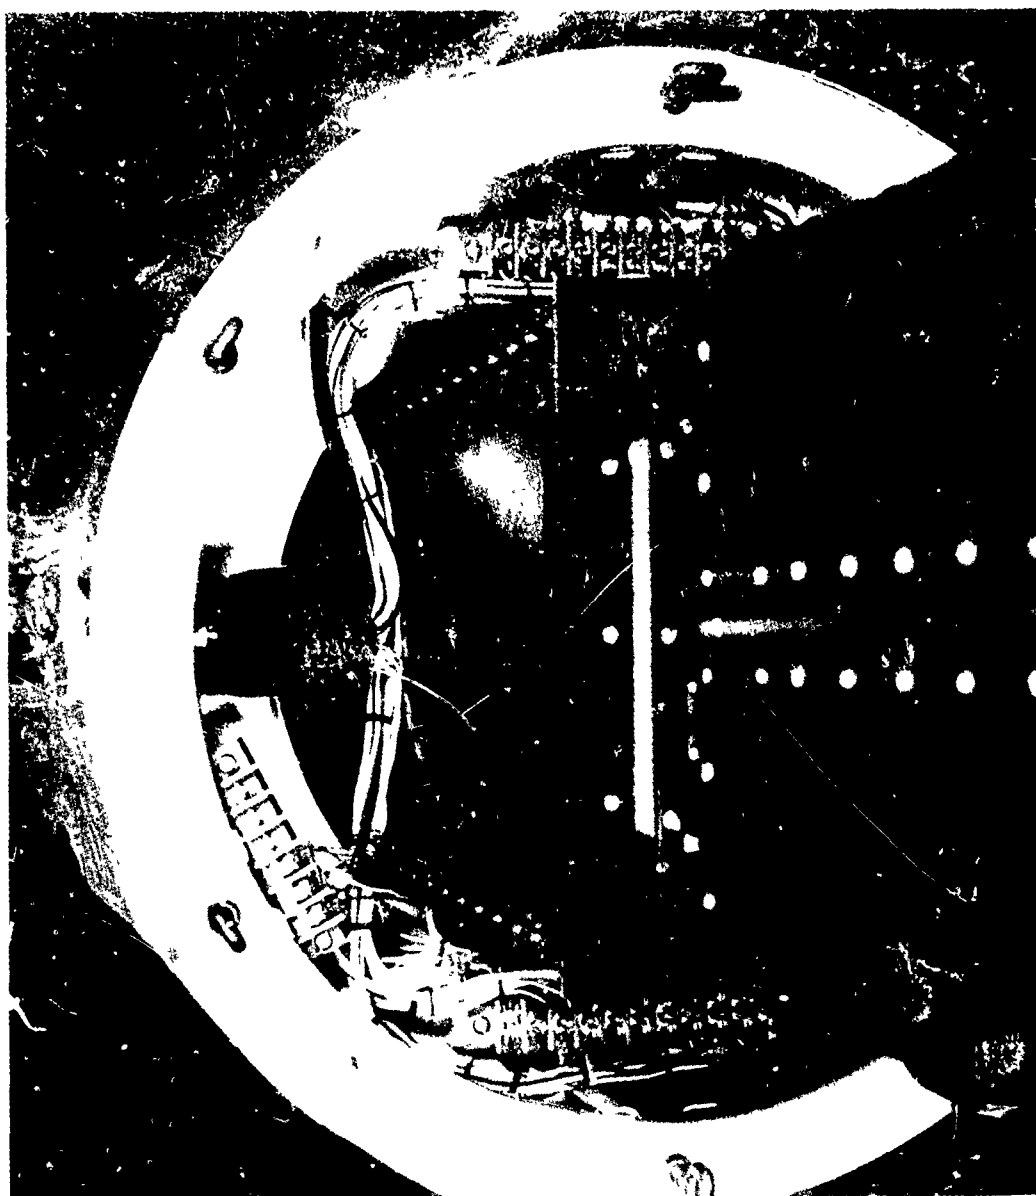
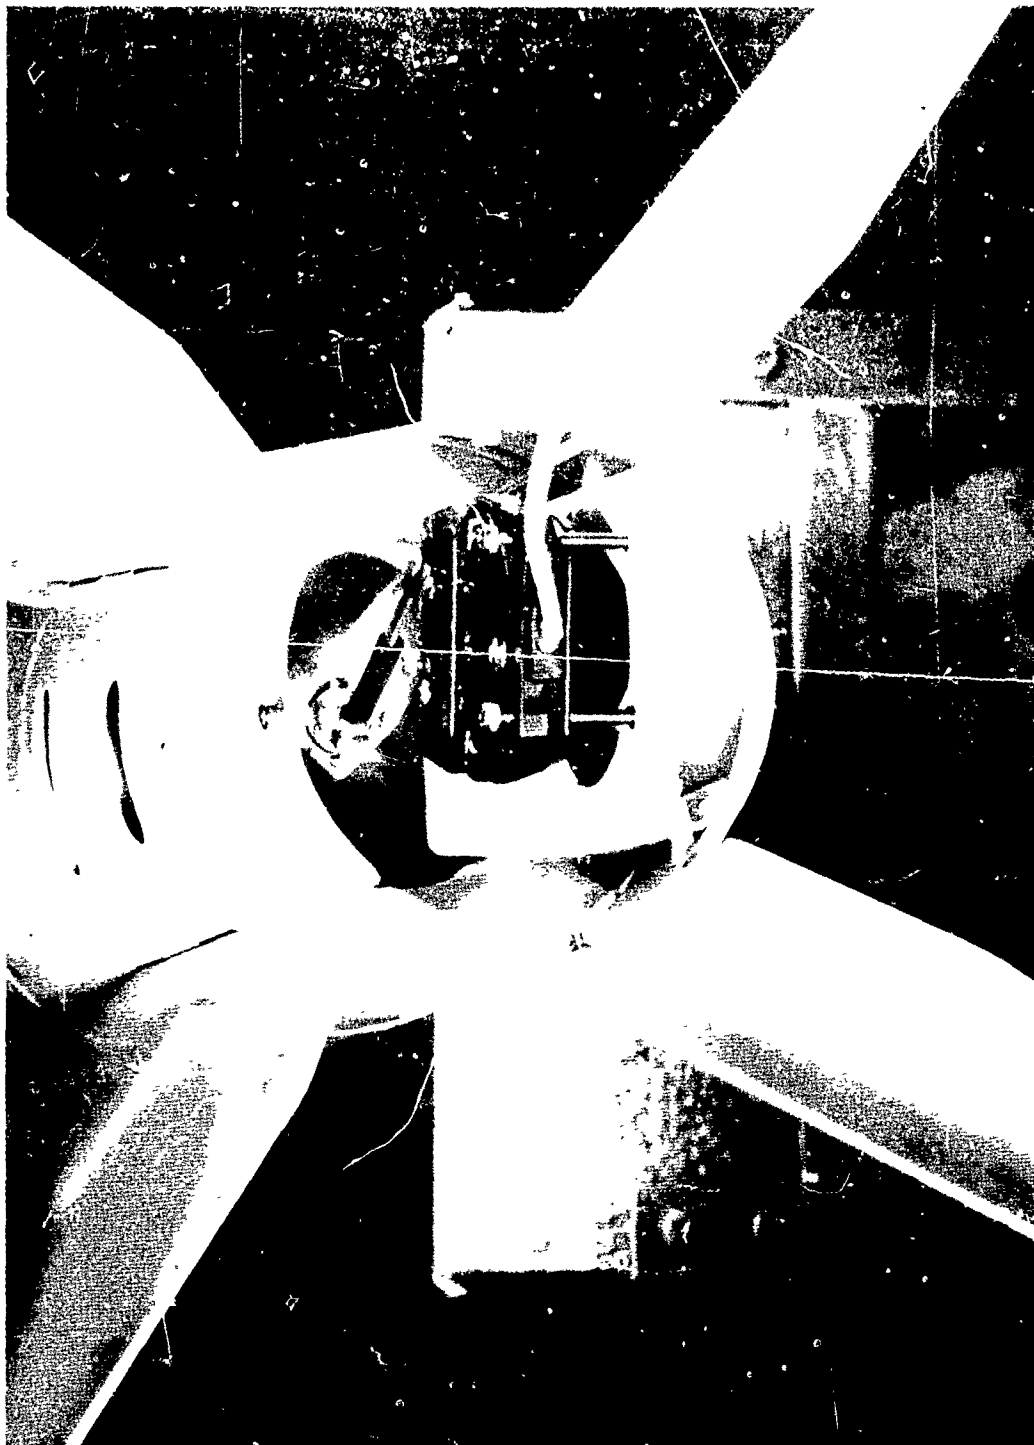
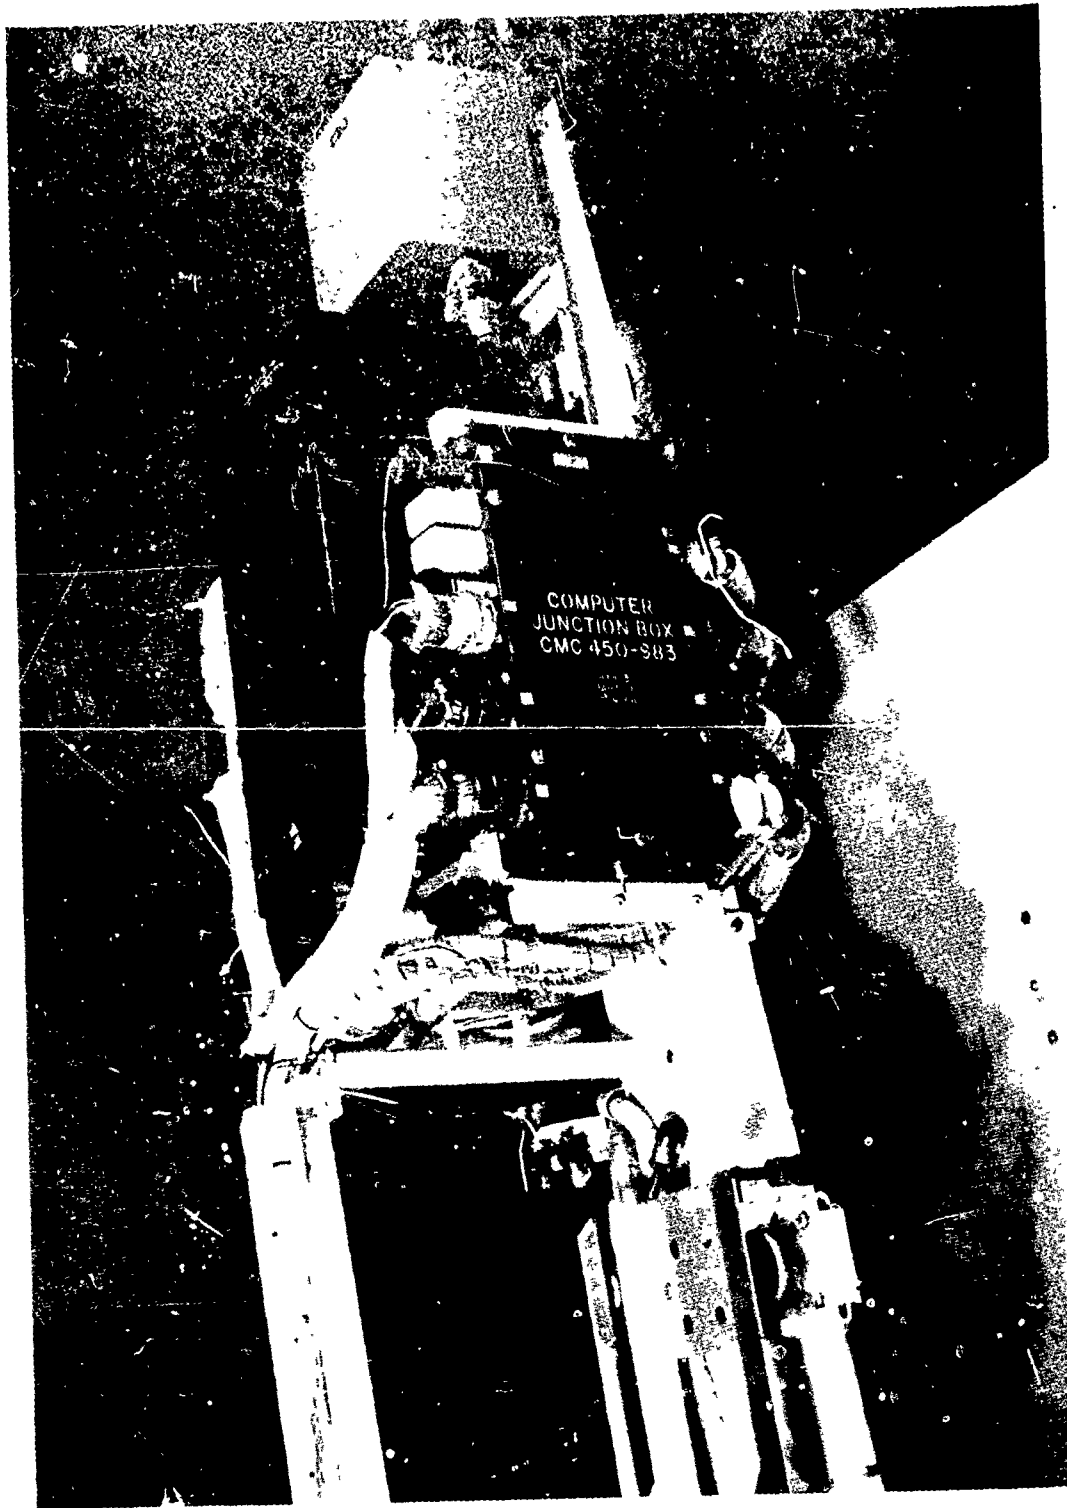
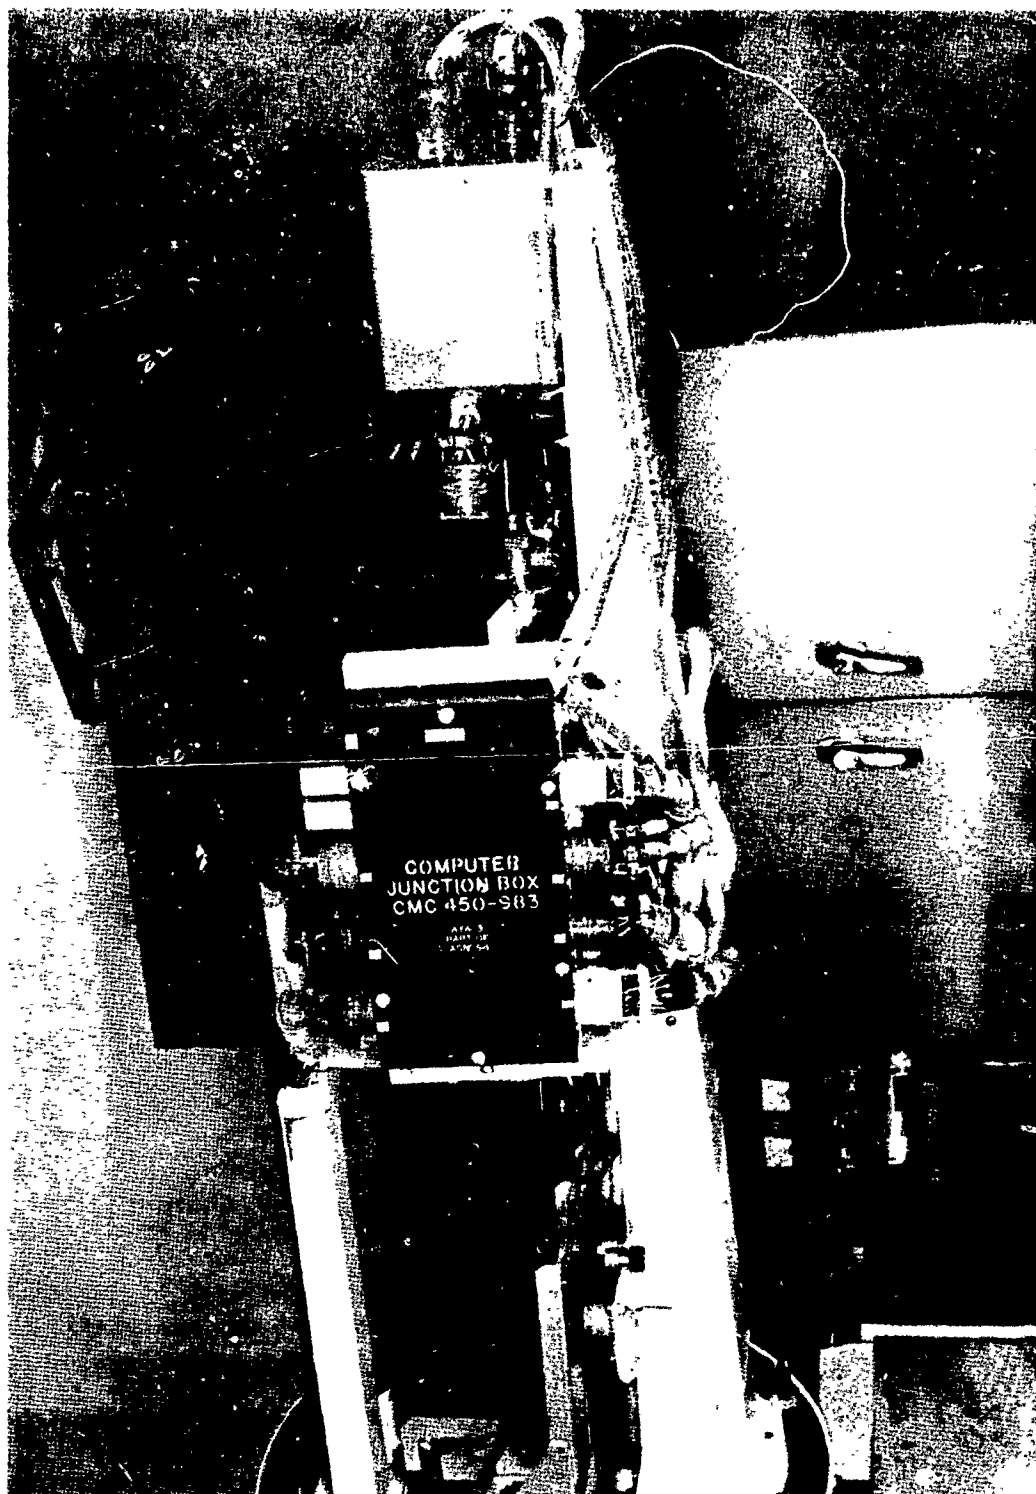
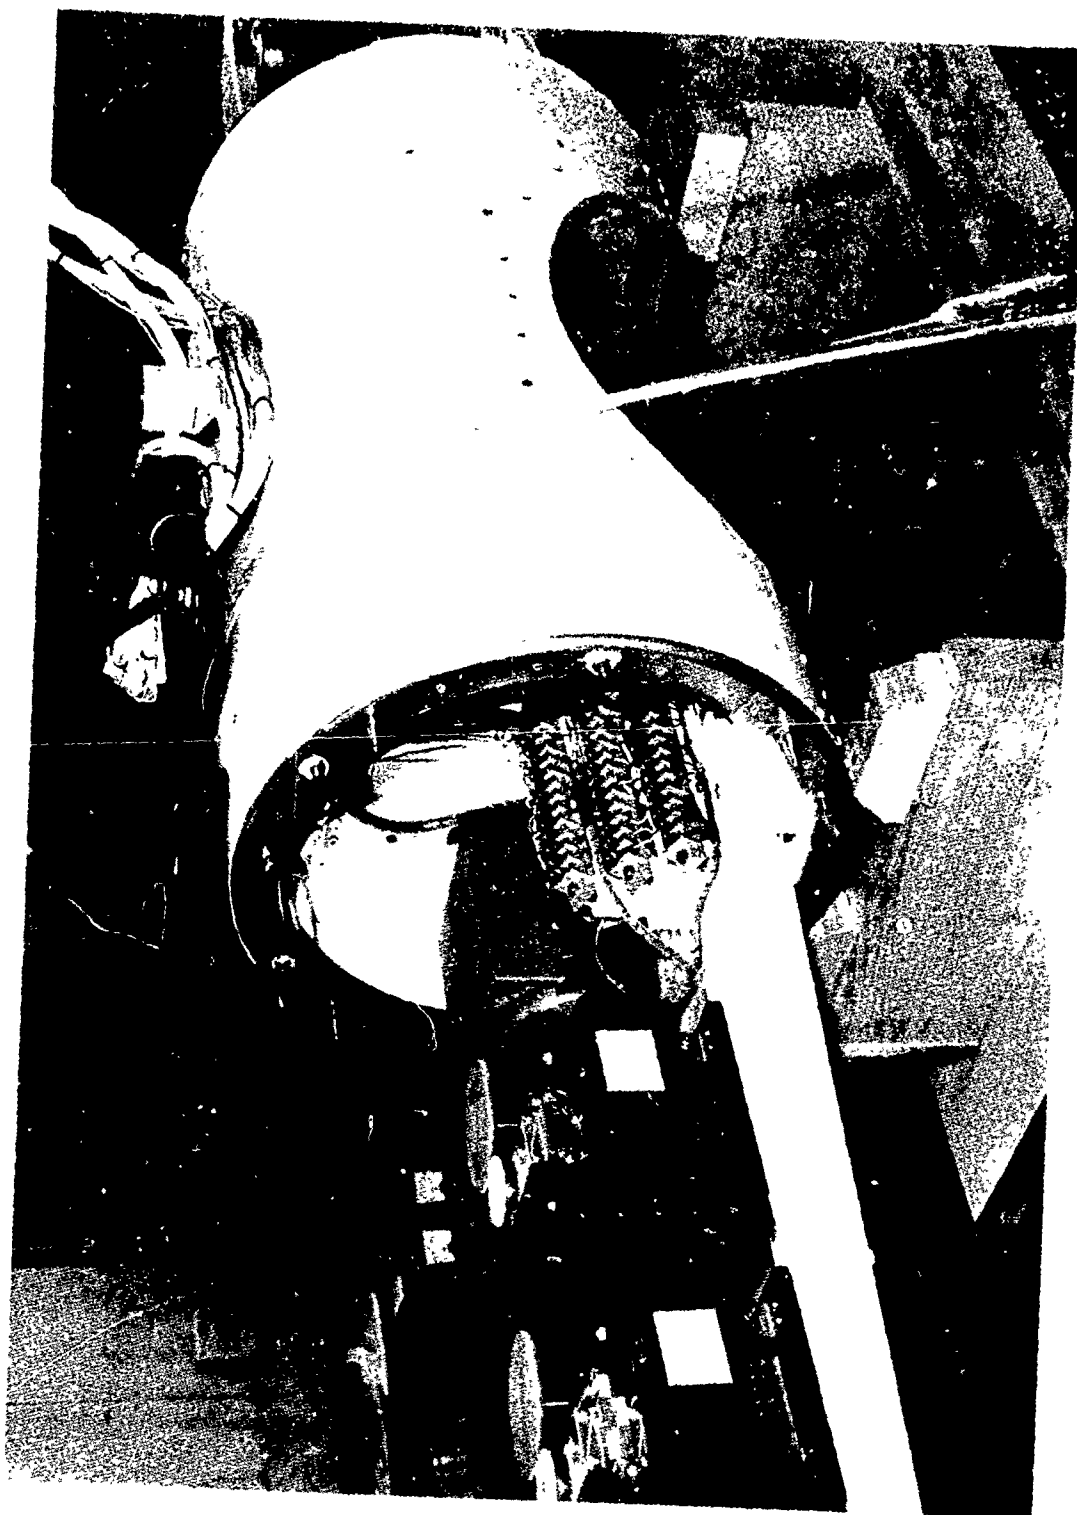
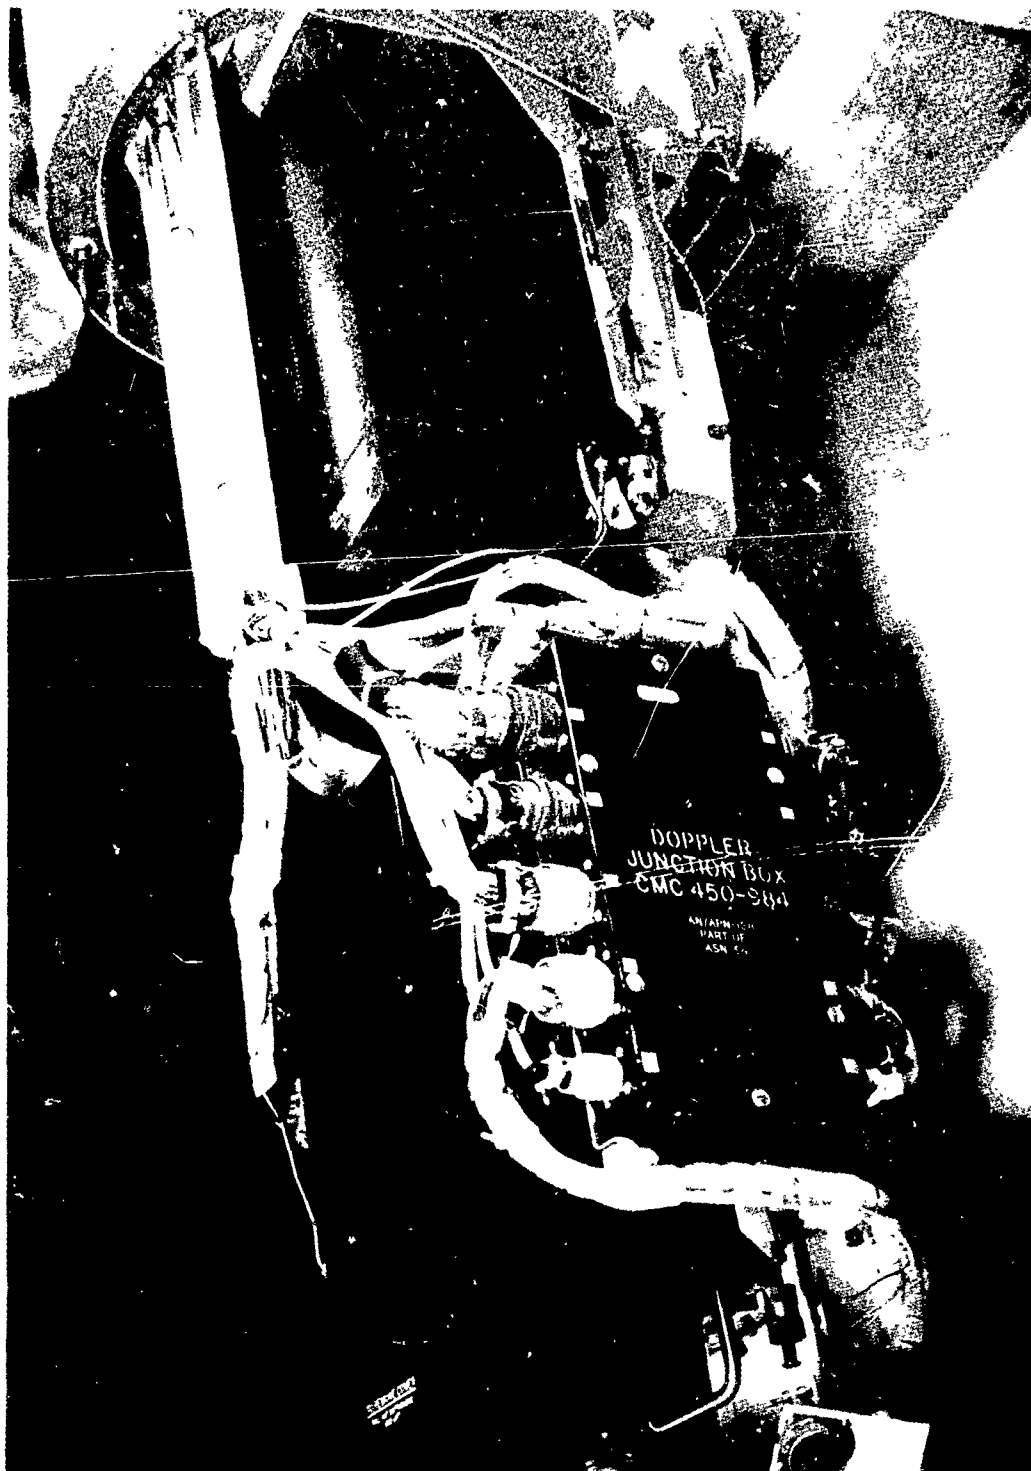
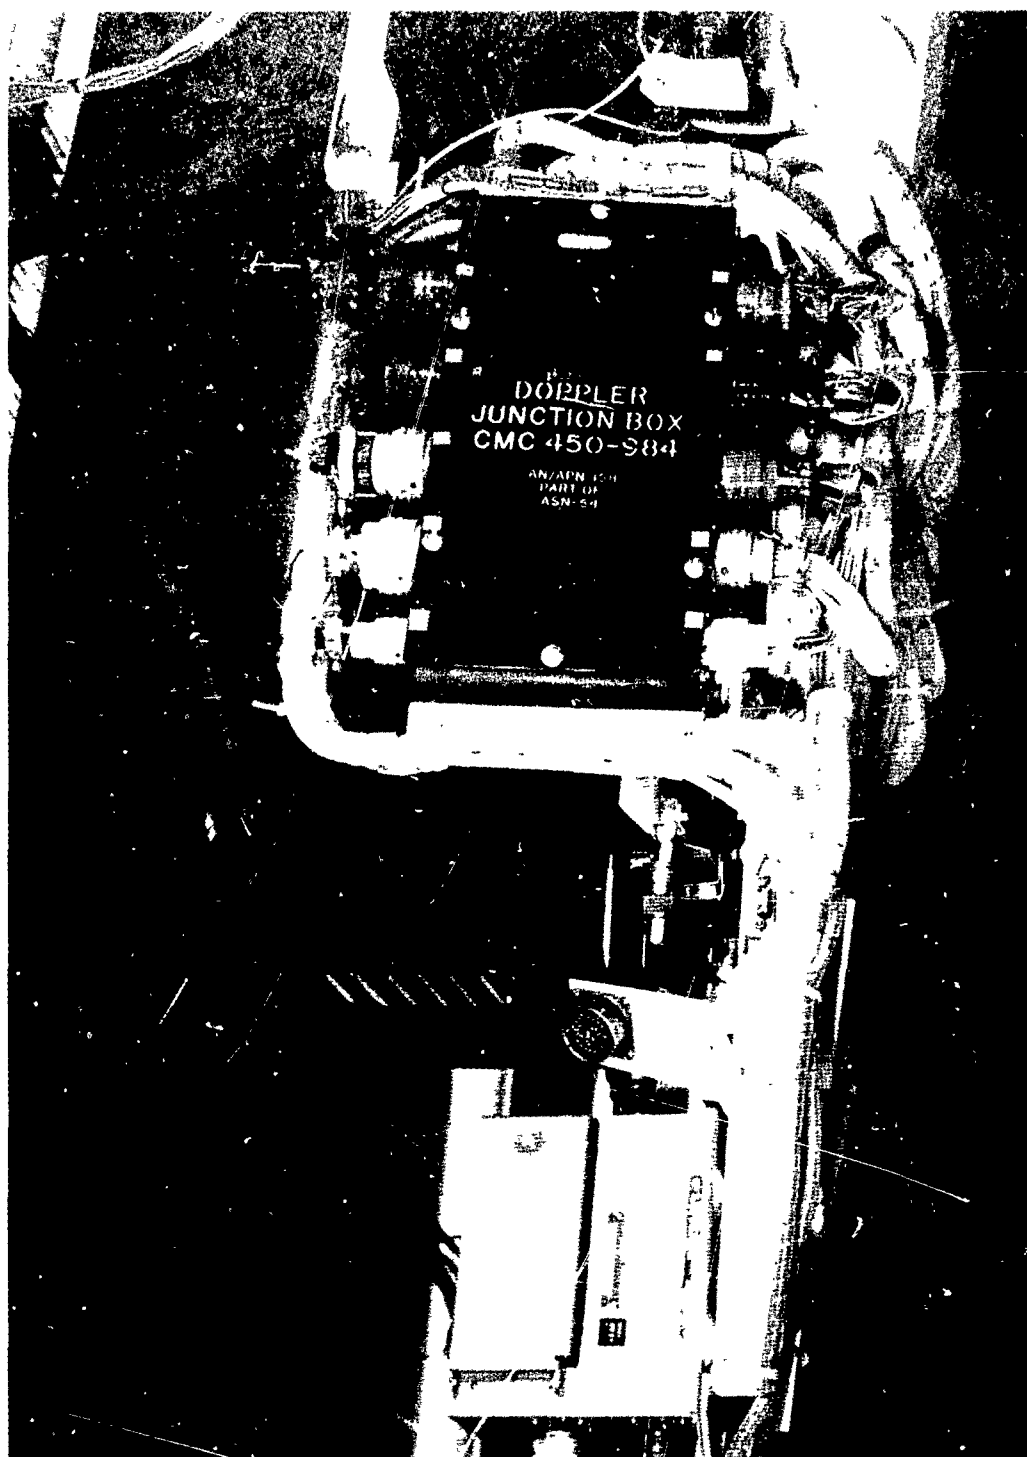
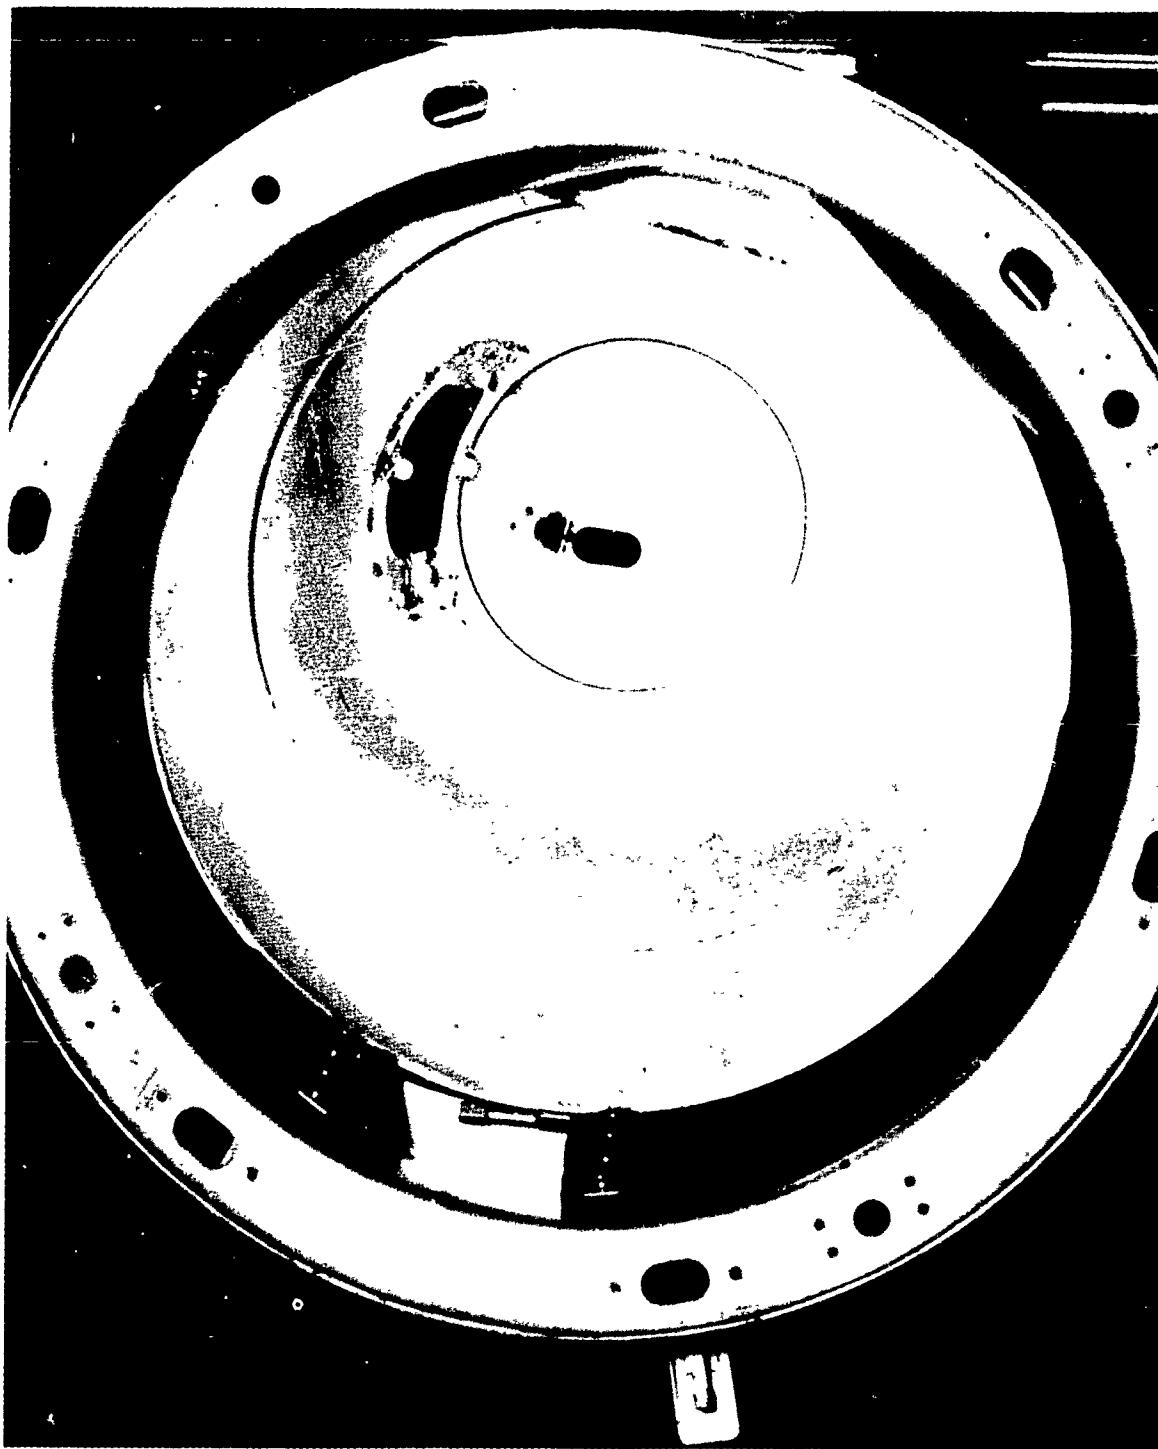
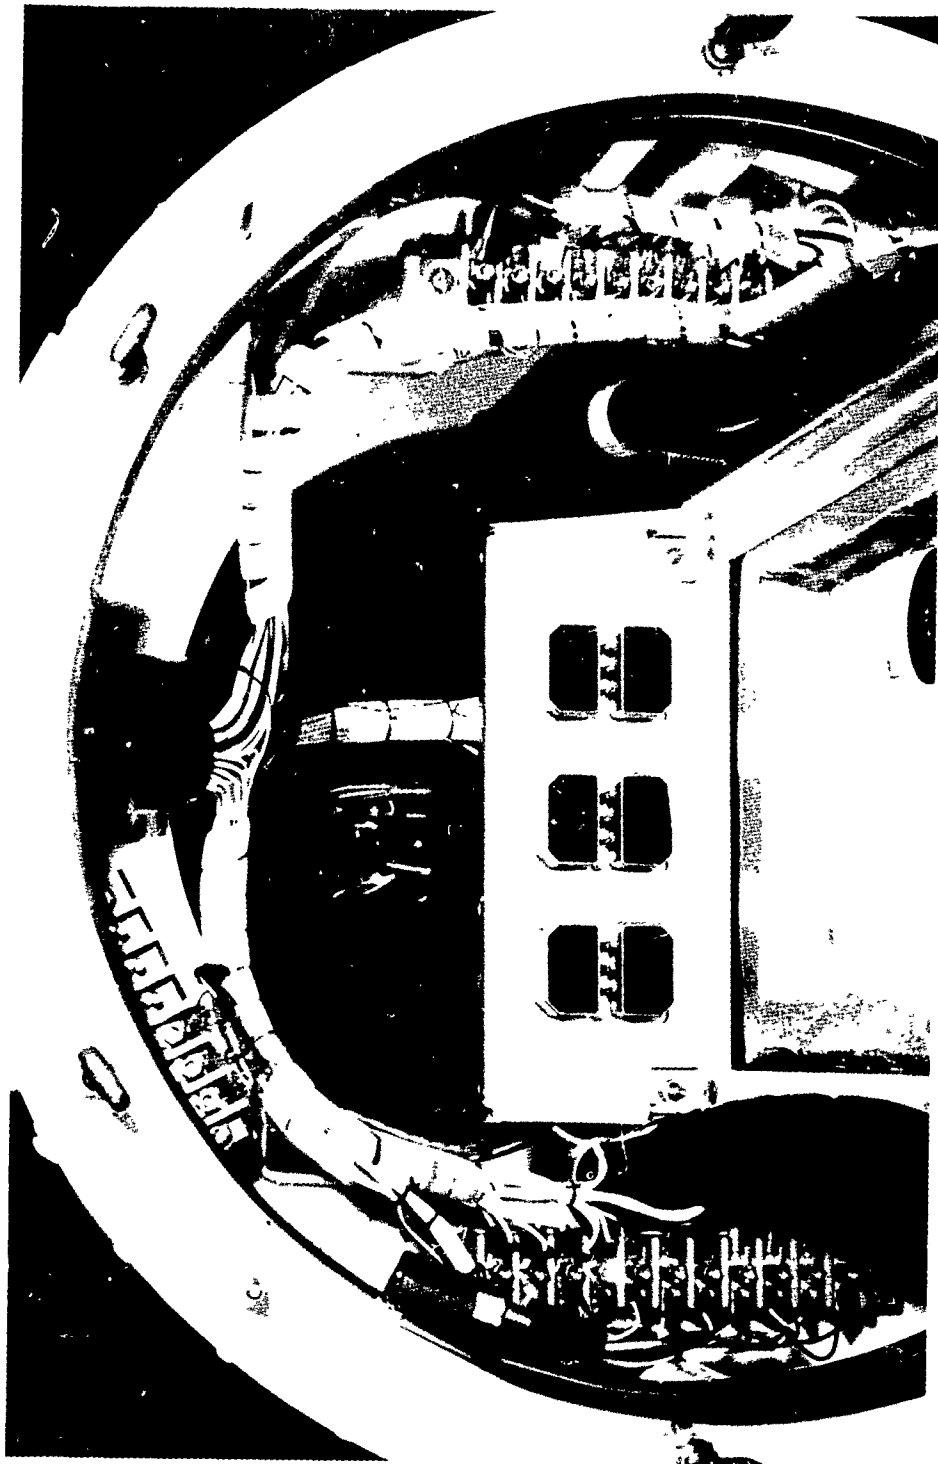
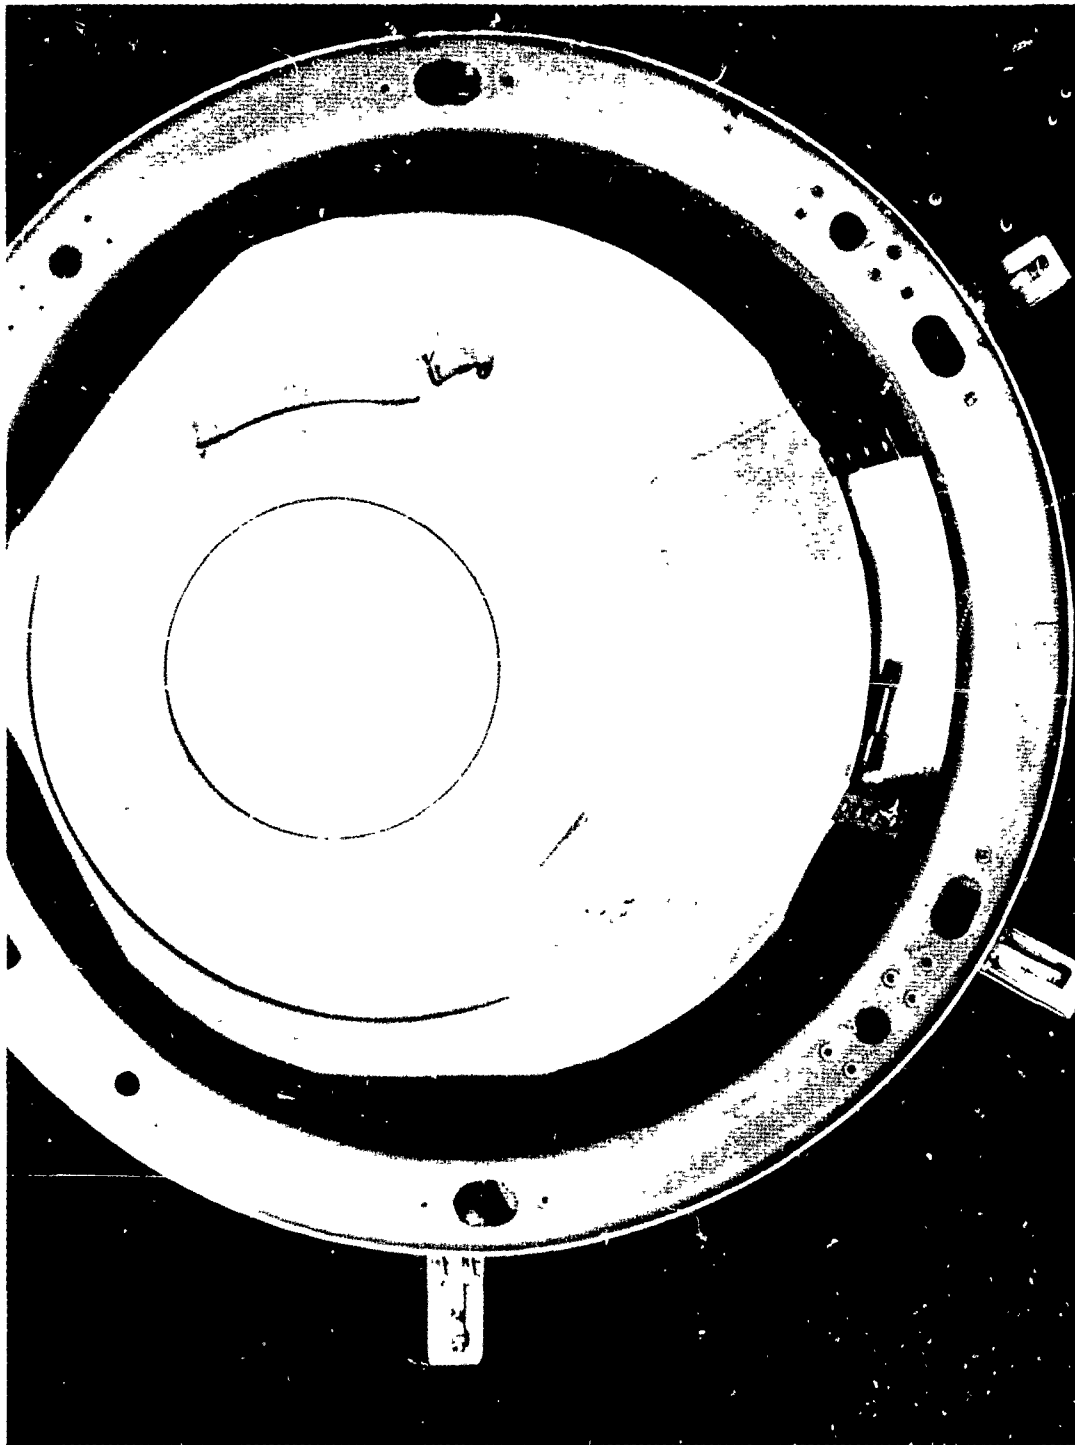
Figure 3-22. Pod 1 Forward Center Section Wiring (End View).

Figure 3-23. Pod 2 Tail Section—Magnetic Compass and Mounting Bracket.

Figure 3-24. Pod 2 Aft Beam Section Wiring (View top Left).

Figure 3-25. Pod 2 Aft Beam Section Wiring (View Left Side).

Figure 3-26. Pod 2 Center Section and Forward Beam Wiring (View Left Side).

Figure 3-27. Pod 1 Forward Beam Wiring (View Left Side).

Figure 3-28. Pod 2 Aft Beam Wiring (View Top Right).

Figure 3-29. Pod 2 Aft Beam Wiring (View Right Side).

Figure 3-30. Pod 2 Aft Section (View Forward).

Figure 3-31. Pod 1 Center Section Wiring (View Forward).

Figure 3-32. Pod 1 Forward Beam Wiring (View Top Right Forward End).

Figure 3-33. Pod 1 Aft End Section (View Forward).

Figure 3-34. Pod 1 Forward Beam Wiring (View Top Right Middle Section).

Figure 3-35. Pod 1 Forward Beam Wiring (View Bottom Left).

Figure 3-36. Pod 1 Center Sections Wiring.

Figure 3-37. Pod 1 Aft Beam and Center Section Wiring (View Left Center).

Figure 3-38. Pod 1 Forward End Section Wiring (View Aft End).

Figure 3-39. Pod 2 Forward End Section Wiring (View Aft End).

Figure 3-40. Pod 2 Forward Beam and Forward End of Center Section Wiring (View Right Side).

Figure 3-41. Pod 2 Forward Beam and Forward End of Center Section Wiring (View Left Side).

Figure 3-42. Pod 2 Aft Beam and Aft End of Center Section Wiring (View Left Side).

Figure 3-43. Pod 2 Aft Beam and Aft End of Center Section Wiring (View Aft Center).

Figure 3-44. Pod 1 Aft Beam Wiring (View Forward End Right Bottom).

Figure 3-45. Pod 2 Aft Beam and Aft End of Center Section Wiring (View Right Aft).

Figure 3-46. Pod 1 Center Section Aft End Wiring (View Right Center Bottom).

Figure 3-47. Pod 1 Center Section. Aft End Wiring (View Left Center Bottom).

As System 1 cables were completed, System 2 cables were fabricated. The wiring was installed directly into the pods and checked out. Following shipment of System 1, System 2 was brought into the test area and checked out on the system test facility. The laboratory cables and Junction Boxes were later installed in the UH-1. Details of the pod wiring can be seen in figures 3-22 through 3-47.

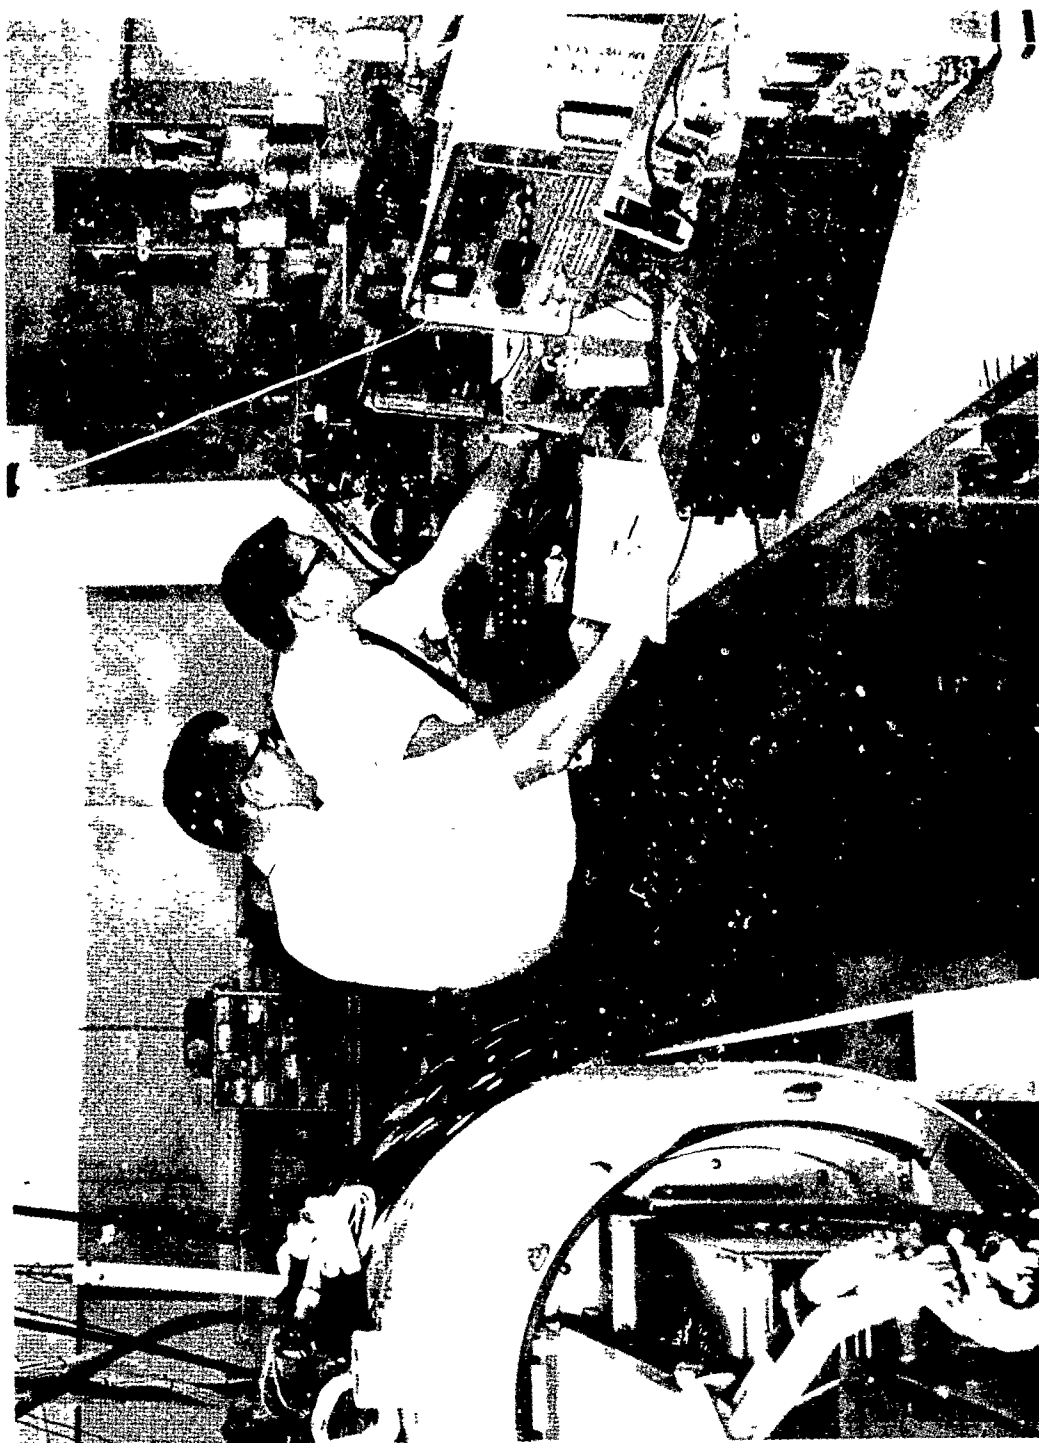
Figure 3-48. Laboratory Facilities—Pod 2 and Cockpit Equipment Checkout.

Figure 3-49. Navigation Set—Testing Facilities.

Figure 3-50. Pod 1 Equipment Checkout.

A complete simulation of the AMPD-224 cockpit display, aircraft wiring using actual cable lengths, and a simulation of the aircraft power source using an inverter and aircraft battery were built in the laboratory at GEOS (figures 3-48 through 3-50); this allowed an early determination of system integration and interaction type problems within a controlled environment. The laboratory facility was completed in late October, 1967. Prior to receipt of the Leiland inverter and the GE battery, house power was used for checkout.

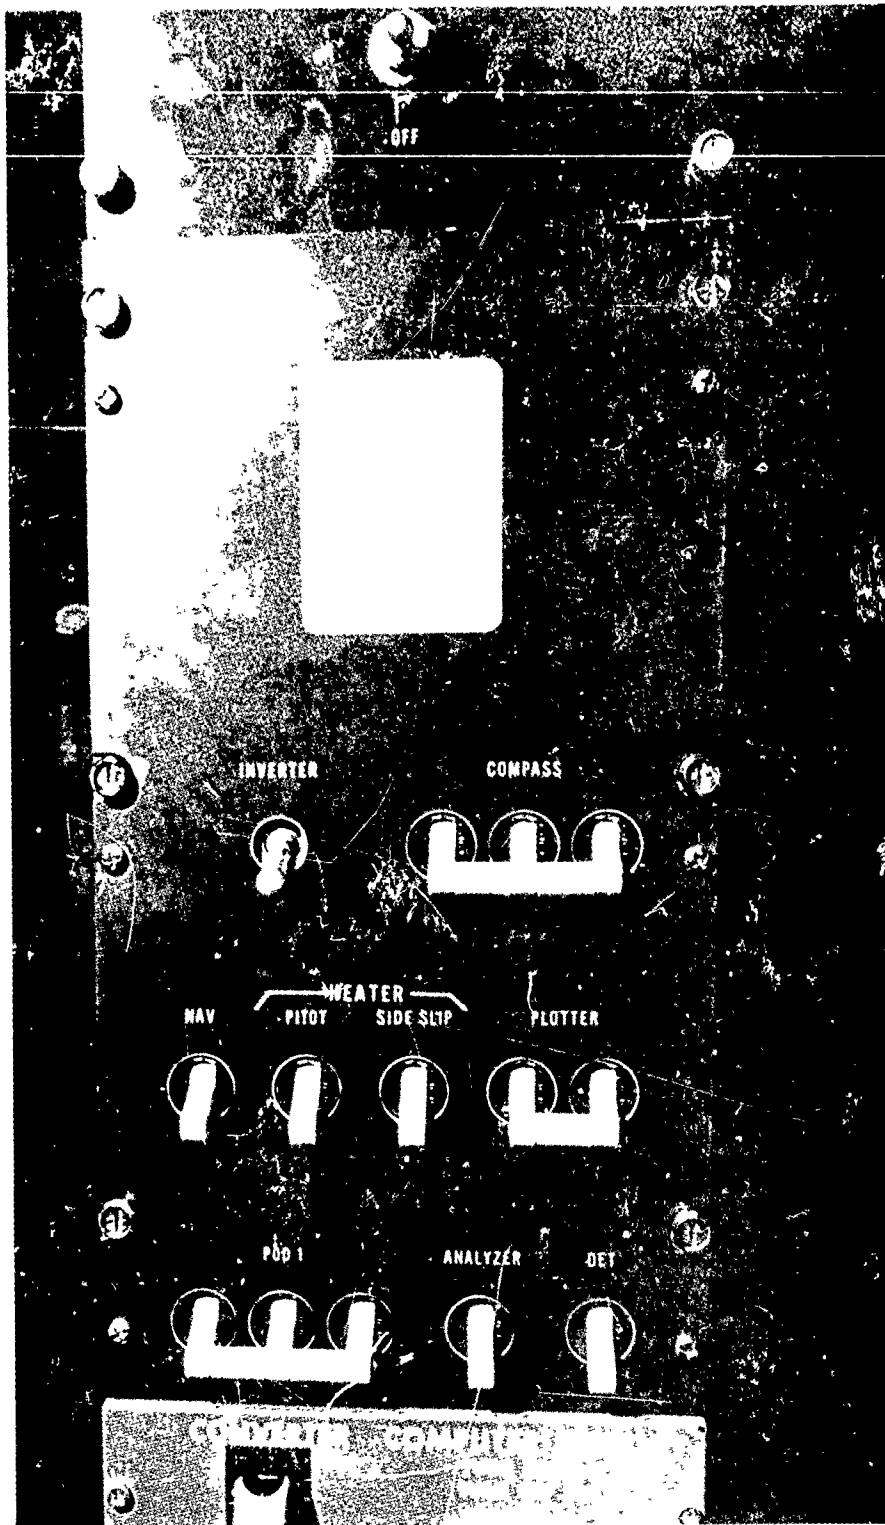
Figure 3-51. Power Panel.

4. On 19 Feb 68, the power panel was found to be incorrectly wired. Some circuit breakers were in the wrong location due to incorrect identification numbers being stamped on the power panel. The power panel was removed and rewired. The +6v Abbott Power Supply was found to be defective. It was removed and replaced.
5. The plotter off-map indication (21 Feb 68) did not function properly. In all other respects, the plotter functioned normally. The navigation subsystem functioned normally. The MRI temperature probe was found to have a defective sensing element. The temperature probe was replaced, and the MRI was found to function normally.

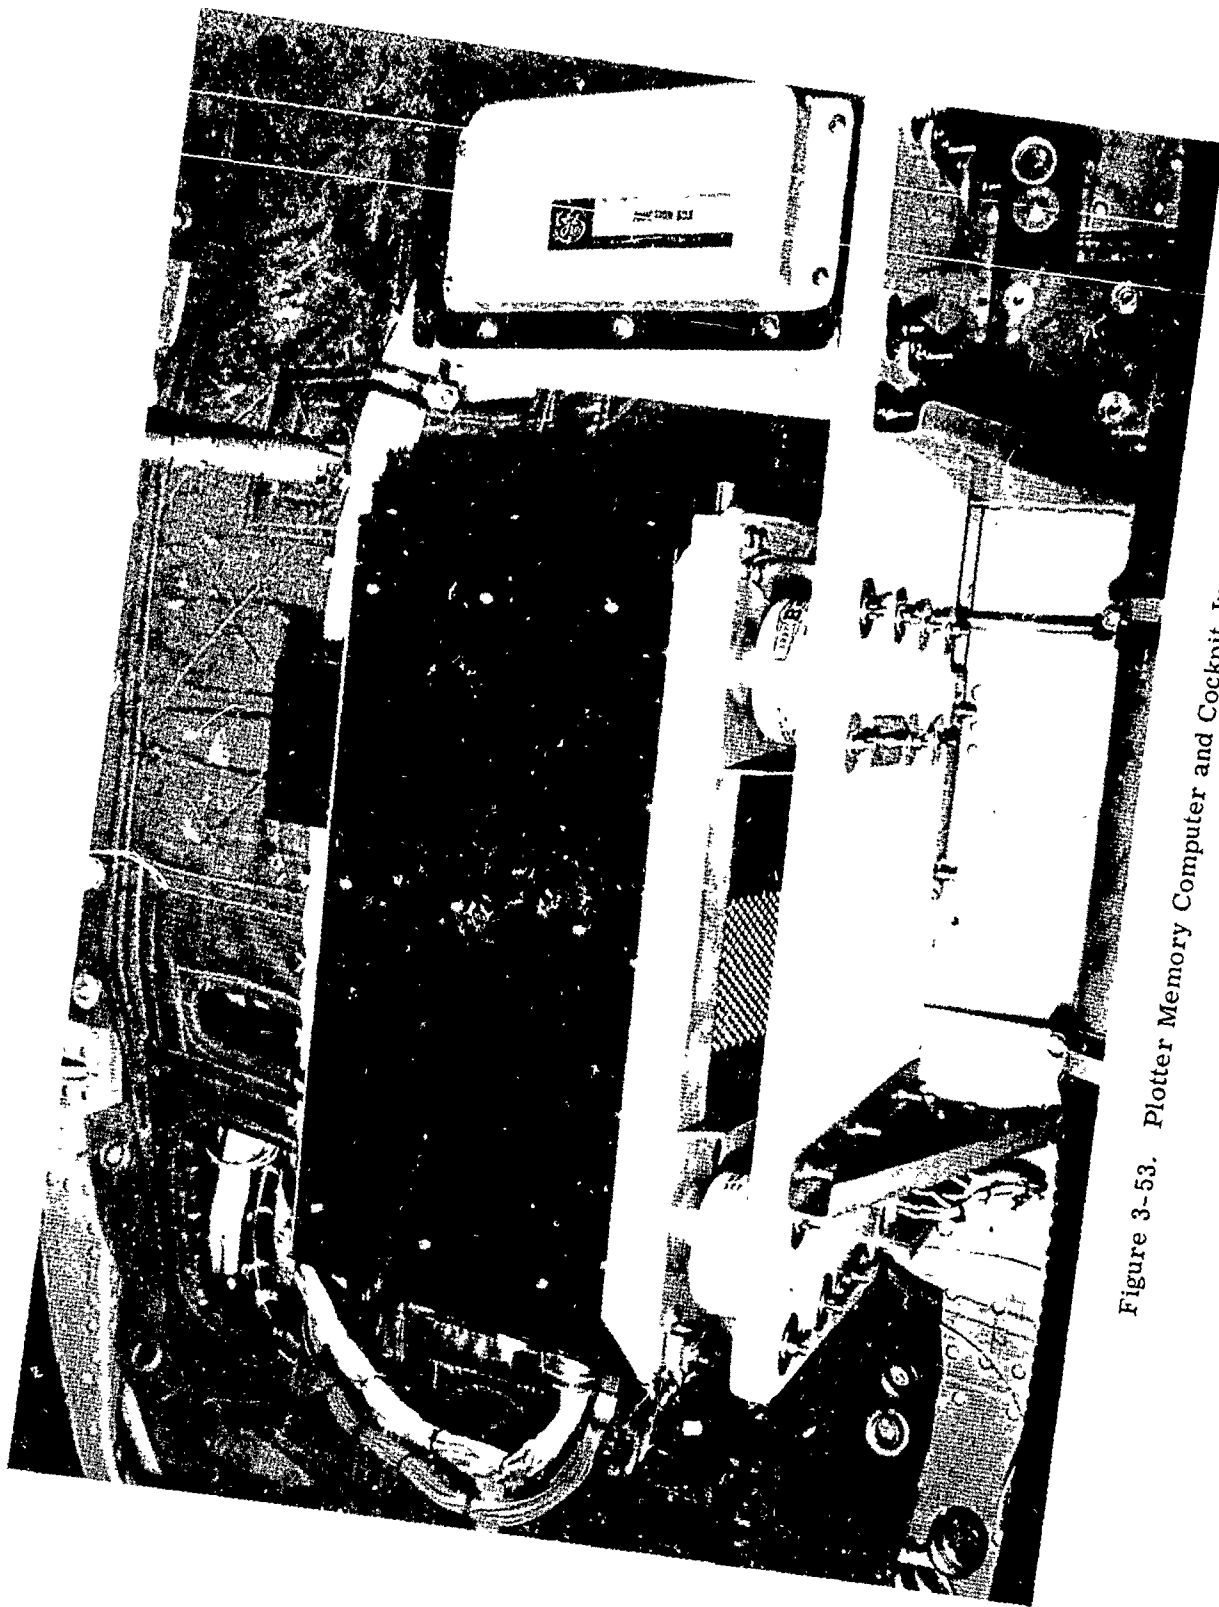
Figure 3-53. Plotter Memory Computer and Cockpit Junction Box.

A decision was made in late May, 1967 to include a system junction box. Its inclusion allows maintenance of subsystems signal flow between pods and between a pod and the aircraft. The system junction boxes and the cockpit junction boxes (figure 3-53) were fabricated at GEOS and installed in the aircraft by Gruman. Simulated J-boxes were fabricated to be used in the laboratory test setup.

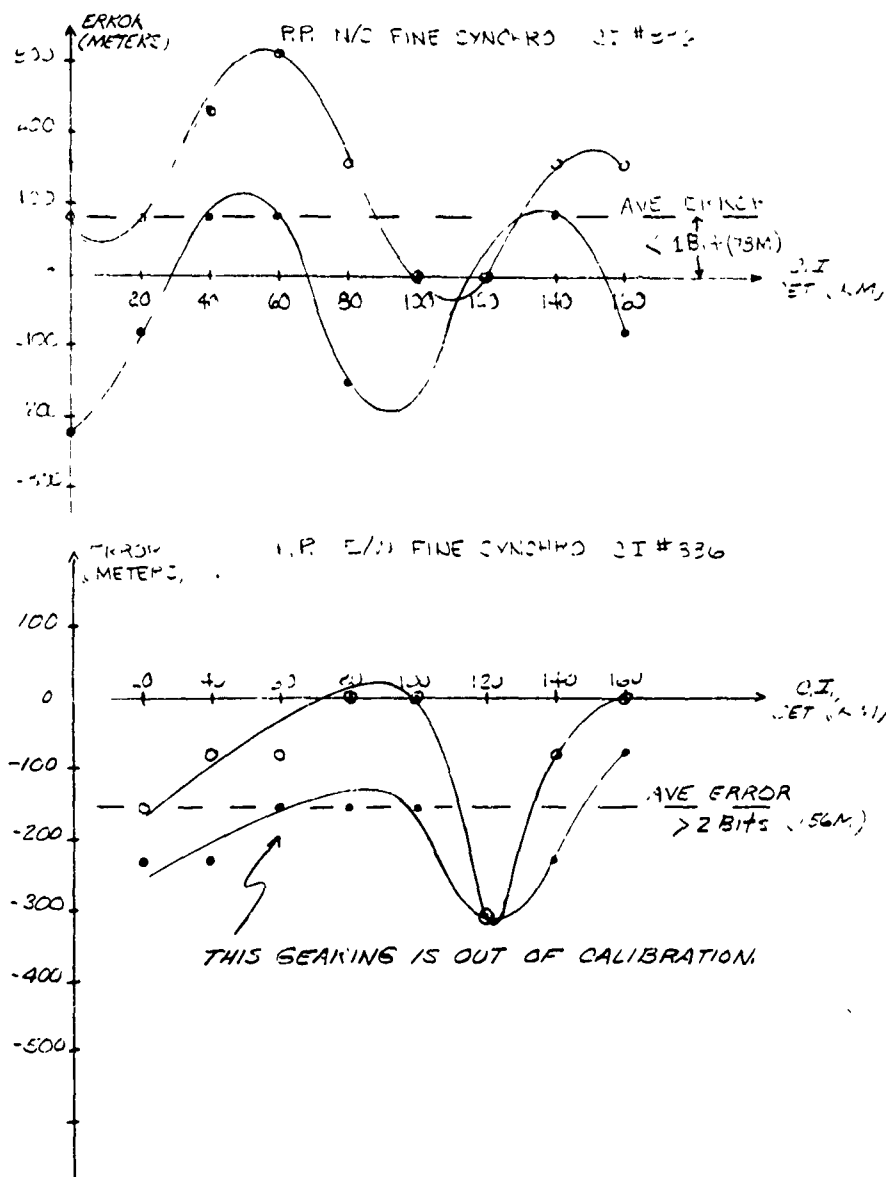
Figure 3-56. Control Indicator 336 Calibration Check of Present Position Readout.

8. Section II of the system test specification was completed (21 Feb 68); the results follow. Accuracy of both the A/D and S/D converters was within specifications. Digital subsystem worked properly. Chemical subsystem functioned properly.
9. The calibration of the control indicator (SN #336) present position readout was checked (21 Feb 68). The checkout indicated that the E/W calibration had slipped since its last adjustment. The control indicator was replaced with a spare unit recently calibrated. The present position data for control indicator SN 336 is plotted in figure 3-56.

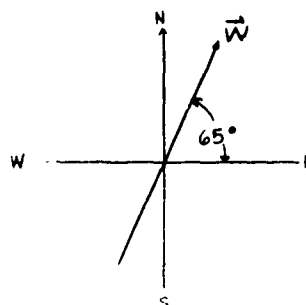
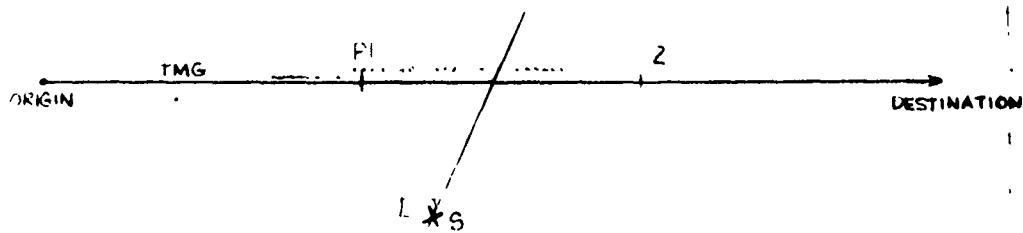
$S/S = 150$ KNOTS
 $TMG = 90^\circ$
 $TAS = 142.2$ KNOTS
 $DRIFT\ ANGLE = 6^\circ$ (LEFT)
 $WIND = 21.82$ KNOTS
 $\theta W = 65^\circ$
 $MATH\ MODEL = 1$
 $TURBULENCE = 0$
 $ORIGIN = 4KM\ N, 1KM\ E$
 $DESTINATION = 9KM\ N, 9KM\ E$
 $MAP\ SCALE = 10KM \times 10KM$
 $THRESHOLD = 2.5$
 $SOURCE = SIMULATED\ CH\ 1$
 $CALCULATION = ITERATION$

Figure 3-57. Problem 3/1.

11. The Meteorological meter on the system test panel was modified (26 Feb 68) to indicate the angle of the side slip sensor when position side slip is selected. One simulated test problem was run. The problem (figure 3-57) produced a correct plot in both magnitude and direction.
12. JOV1-B Mohawk Aircraft left 27 Feb 68 for Grumman Aircraft Engineering Corp in Bethpage, L.I., for a compass swing and RFI checkout.

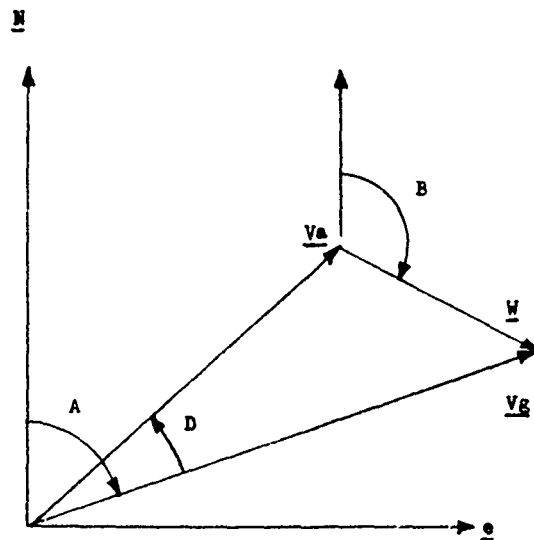
Figure 3-58. Vector Diagram for Groundspeed, True Airspeed, and Wind.

The vector relationship between groundspeed (V_g), true airspeed (V_a), and wind (W) is shown on figure 3-58. Nomenclature that applies is:
